External Wall Inspection

Façade Building

55 Advent Avenue,
Manchester, M6 8YU

ASSESSMENT REF.RB-BC3DA8

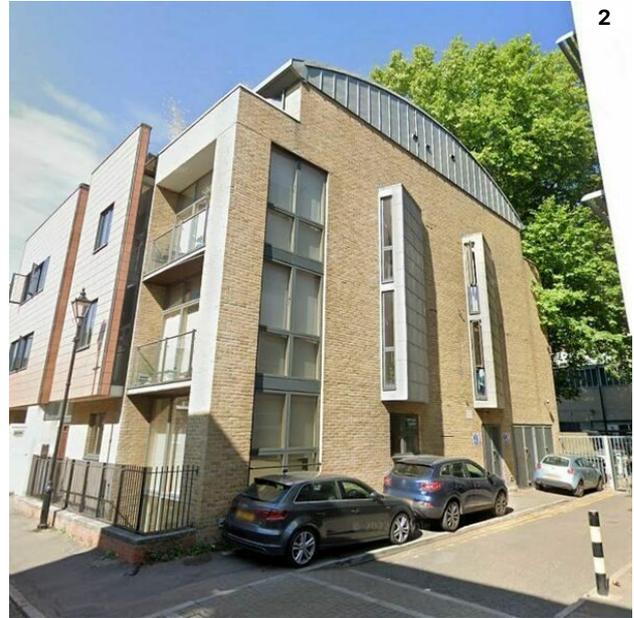
Elevation: West

People use doors to get in and out of the building.

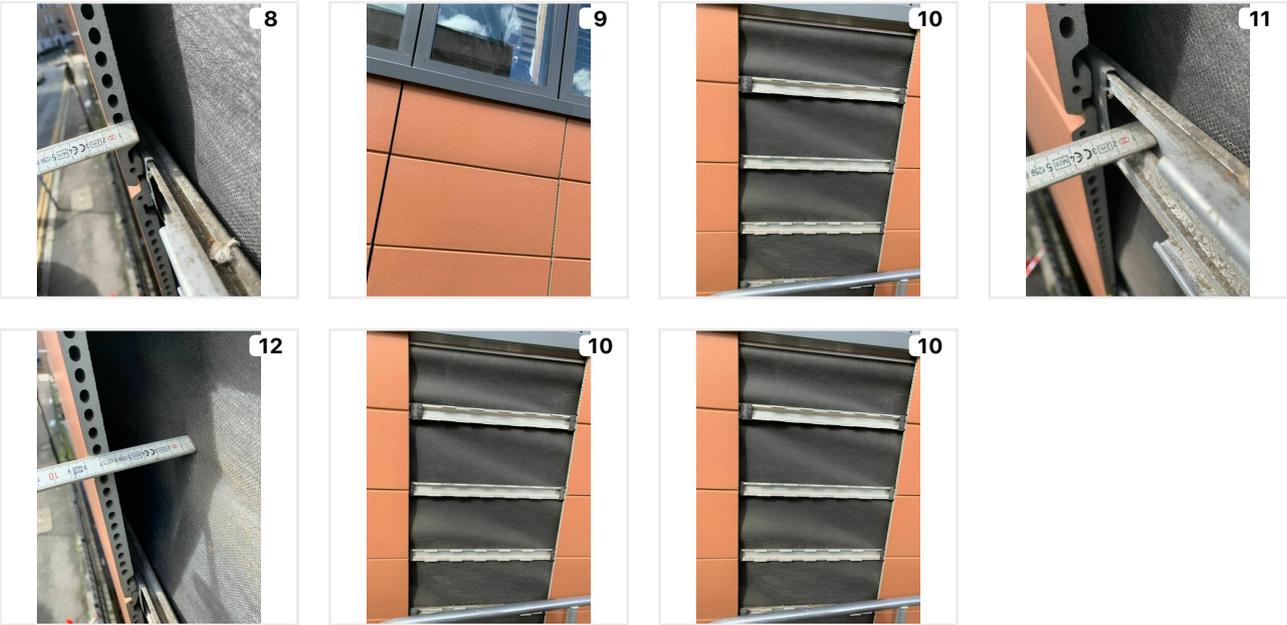
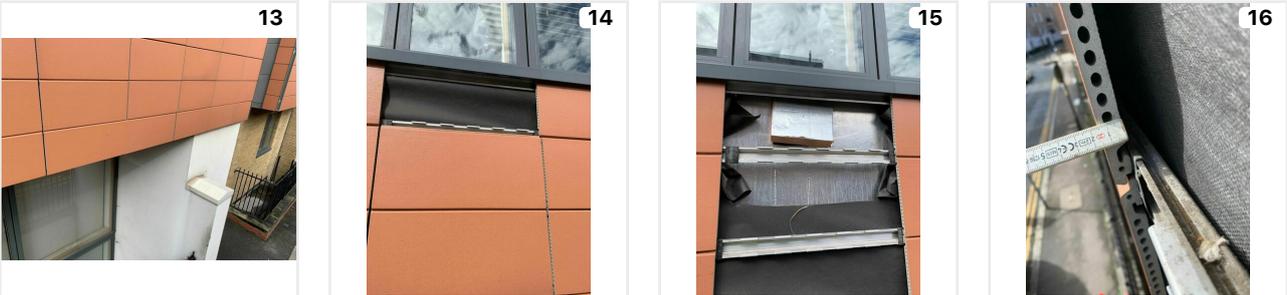
Inspection: QZF4X9

Elevation • Location
North Elevation • First Floor Slab and Window.

7 Elements	Thickness/Depth	Material	Photo Ref.	Rating (BS EN13501)
Surface Finish	15mm	Terracotta Tile	8, 9	A1 - Non-Combustible
Cavity Support Frame	20mm	Galvanised Steel Horizontal Rails with Hook-on Clips	10, 11	A1 - Non-Combustible
Cavity	60mm		12	
Other		Breather Membrane (Textile)	10	D - Highly Combustible
Insulation	50mm	Phenolic Foam Insulation	10	C - Combustible
Consists of a weather-proof external lining				
Other		Breather Membrane (Textile)		D - Highly Combustible
Inner Leaf		Concrete Slab		A1 - Non-Combustible

None

Backing Wall Sits On The Floor Slab
