Fire Risk Appraisal of the External Walls (PAS 9980:2022)

Façade Building

55 Advent Avenue, Manchester, M6 8YU

Blueprint (FRAEW)

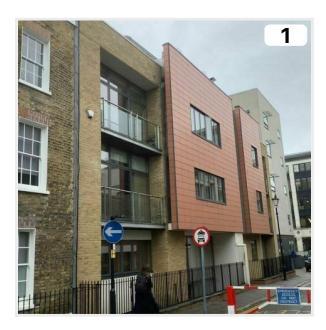
Wall Construction: Terracotta Tile Rain-screen Cladding

7 Elements	Thickness/Depth	Material	Rating (BS EN13501)
Surface Finish	15mm	Terracotta Tile	A1 - Non-Combustible
Cavity Support Frame	20mm	Galvanised Steel Horizontal Rails with Hook-on Clips	A1 - Non-Combustible
Cavity	60mm		
Other		Breather Membrane (Textile)	D - Highly Combustible
Insulation	50mm	Phenolic Foam Insulation	C - Combustible
Consists of a weath	er-proof external linin	g	
Other		Breather Membrane (Textile)	D - Highly Combustible
Inner Leaf		Concrete Slab	A1 - Non-Combustible

None

It is our professional opinion that all combustible materials associated with this wall type should be removed and replaced with materials that achieve a Euroclass A2 (limited combustibility) rating or better. Instillation of cavity barriers to manufacturer's recommendation.
