External Wall Inspection

Façade Building

55 Advent Avenue,
Manchester, M6 8YU

ASSESSMENT REF.RB-BC3DA8

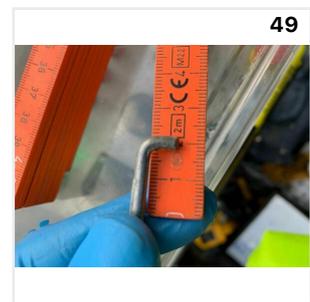
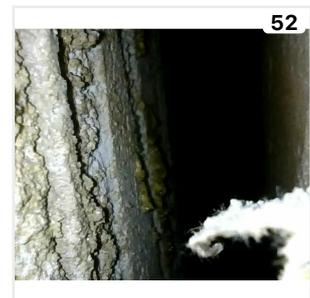
There is no cavity barrier at the slab level.

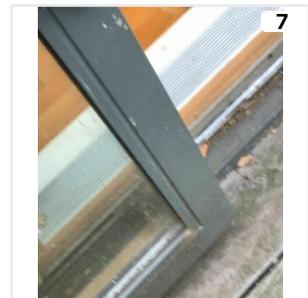
No kite-marks on the glass
